Manhole Inspection Summary

Manhole # S09Y__002MH

Insp Date: **4/22/08 2:27 PM**

Location Address: **1229 PINE Heights**

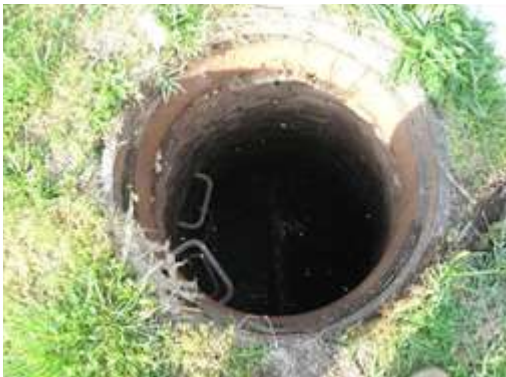
Defect 3

Frame Offset: **1.5** (in.) Condition: ☒ Sound ☐ Cracked ☐ Leaks

offset

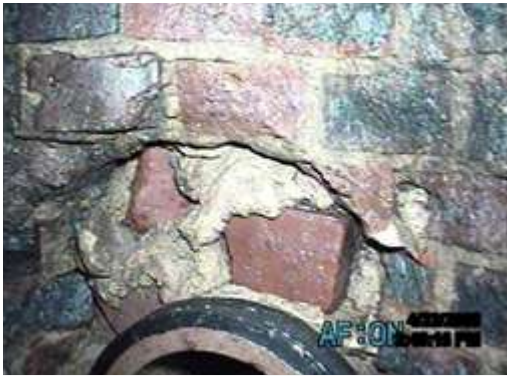
Defect 2

Infiltration: ☐ None ☐ Joint ☐ Cracks ☐ Mortar ☐ Roots ☒ **Wall**

patch job at 9 oclk signs of infiltration

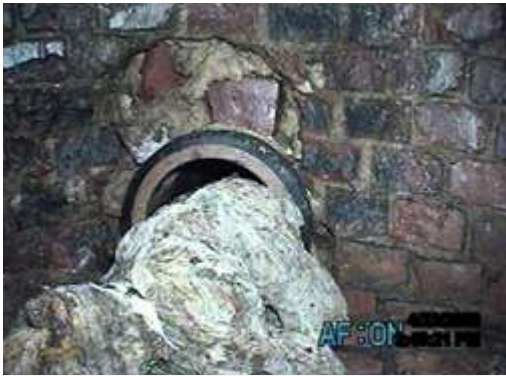
Defect 4

Condition: ☐ Sound ☐ Cracked ☐ Root Intrusion ☐ Deteriorated ☐ Leaks ☒ **Debris**

bench debris

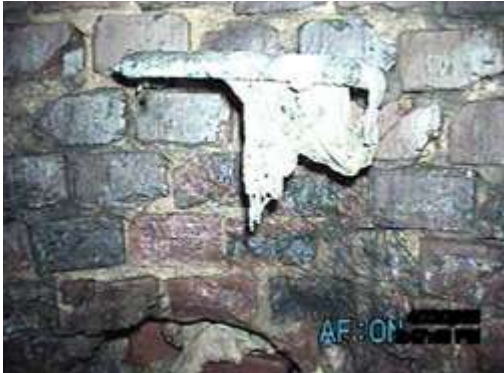
Defect 1

Surcharge ☒ **Evidence Of Surcharge** Depth: **3** (ft.) ☐ Active Surcharge Present

evidence of surcharge 3 feet

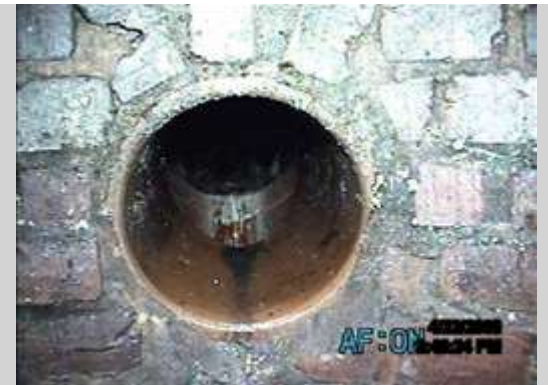
3 O'Clock Inflow

Drop: **Outside** Rod and Bar
Angled: **Yes** Reading: **10.47** (ft.)
Inv Depth: **11.47** (ft.)

Drop Condition: **Open**

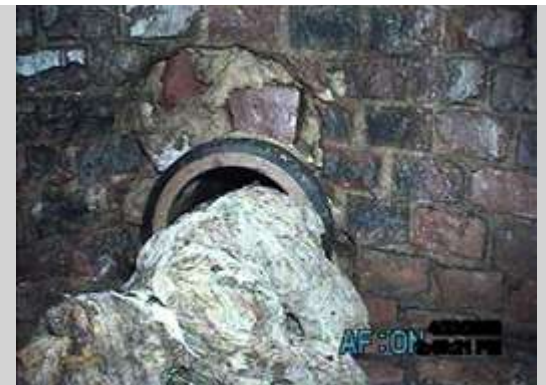
9 O'Clock Inflow

debris covering bench as well as front of 9 o'clock

Deposits: ☐ None ☐ Mud ☒ Sludge ☒ Debris ☐ Grease

Silt Depth: **8** (in.) Deposits Extent: **Heavy**
